*HEAT TRANSFER AND EROSION IN THE ARES
75 MM HIGH VELOCITY CANNON - VOL II*

Calspan Technical Report No. VL-5873-D-1

**ARES, INC.
PORT CLINTON, OHIO**

**OCTOBER 1977
PURCHASE ORDER NO. 1438**

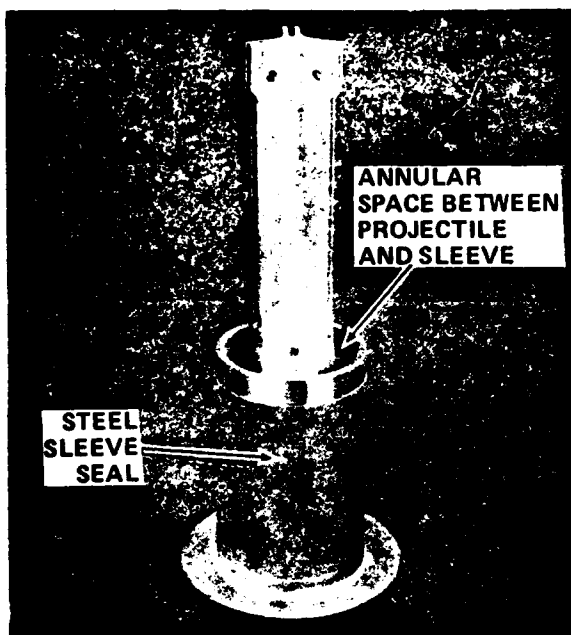
**STEP 1. PROJECTILE AND PLASTIC SEALS
INSERTED INTO FORWARD STEEL
SLEEVE**

**STEP 2. ANNULAR SPACE FILLED WITH SILI-
CONE ABLATOR**

**STEP 3. PRE-CUT POLYPROPYLENE DISC IN
PLACE**

**STEP 4. PRE-FORMED POLYPROPYLENE CAP
IN PLACE. ASSEMBLY COMPLETE.**

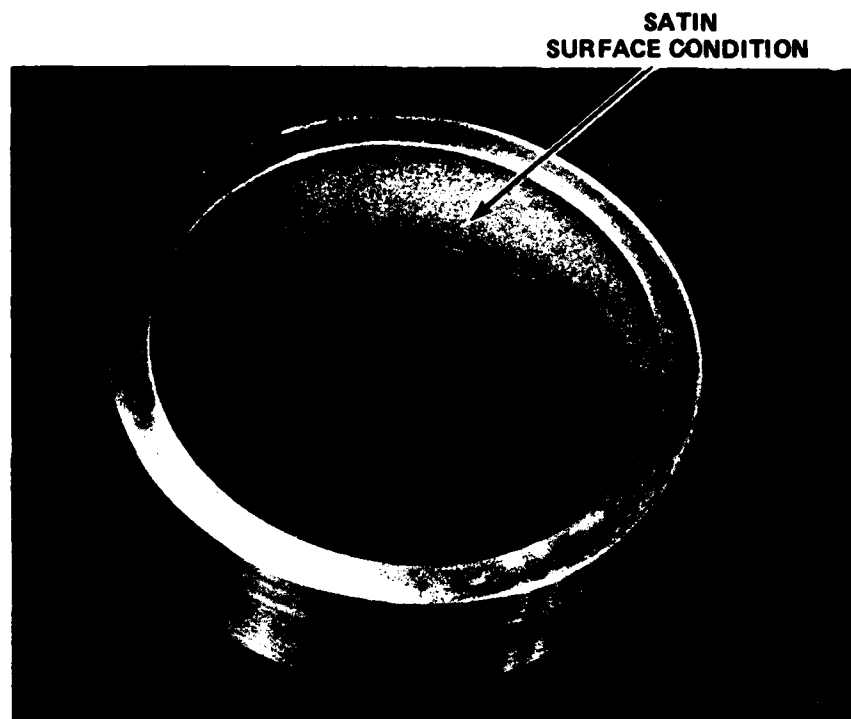
TYPICAL SOFT (LC) CHROME RING-
AS PLATED

SOFT CHROME RING R IX
AFTER EIGHT SHOTS

As with the 1010 steel, negligible erosion was also found in the firings of the low contraction chrome plated Ring R IX. This ring is shown in Figure 23 as plated and after eight standard shots. Erosion indexing marks are clearly visible after test. Weight loss measurements indicate essentially no erosion in five shots. Some very minor material loss was experienced in three shots where the ring had been inadvertently inserted in reverse. This ring reversal (resulting in a sharp entrance edge) subjected the ring entrance edge to very severe heating and erosion conditions, much more severe than in normal operation. Due to this increased severity, some loss of the Vascomax 300 substrate material at the entrance edge was produced. With its loss, actually beneath the chrome plate, one would have expected the chrome to chip or break at this edge. Visual examination of the edge under a stereo microscope showed, however, little loss of the chrome, thus demonstrating the toughness of the low contraction chrome and the superior bond

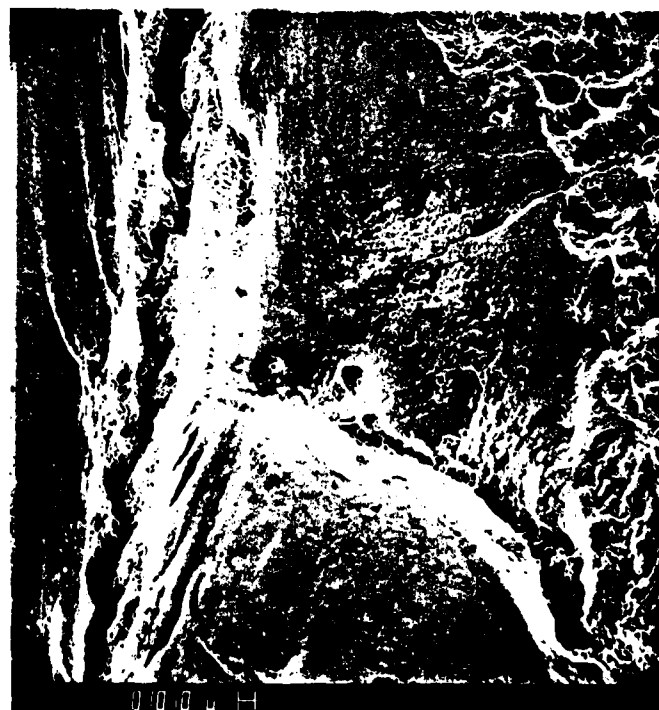
Figure 30 SAME SPECIMEN AS ABOVE AT HIGHER MAGNIFICATION (SEM)

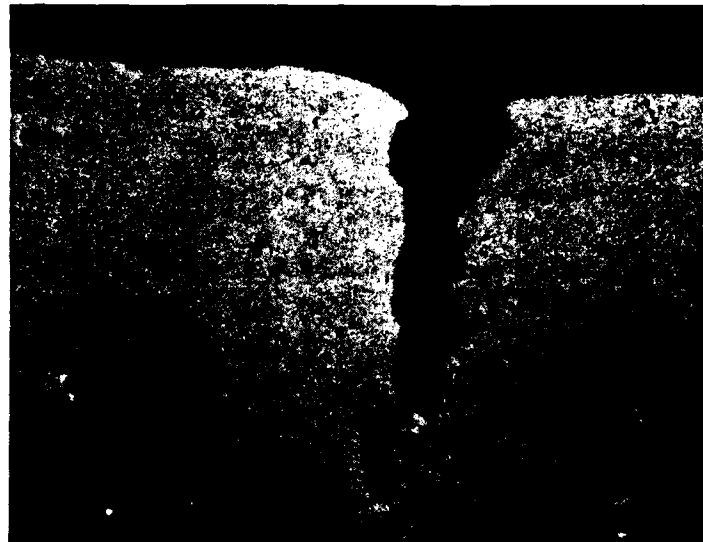
Figure 36 4340 STEEL EXIT RING CROSS-SECTION AFTER 19 SINGLE SHOTS (80X)
